## The UL packets miss Due to RRU carrier mask

Equipment: T5000

BBU: 5GNR\_ax.tdd.fr1.2.2.3.462\_r50381\_m435\_V3.5SP03

RRU: D.1.1.B13S

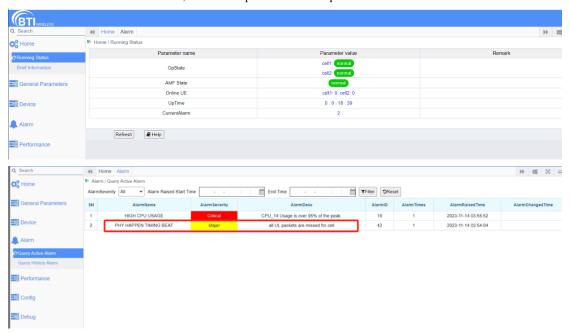
There are two cells. Cell 1 is normal, and the UL packets miss is reported in cell 2.

The configuration parameters are normal and consistent with cell 1. RRU receive and emit is normal. PTP synchronization is normal. Up base band power is normal, down base band power is -60. CBRS is not enabled. UL packets miss in cell 2 is displayed at the physical layer.

The default RRU carrier mask is 15, and the RRU2 carrier mask is 0.

Change the carrier mask of RRU2 to 15. The alarms are cleared.
